HYDROLOGY OF GLACIAL LAKES, FORT SISSETON AREA

Perry H. Rahn

Department of Geology & Geological Engineering
South Dakota School of Mines and Technology
Rapid City, SD 57701

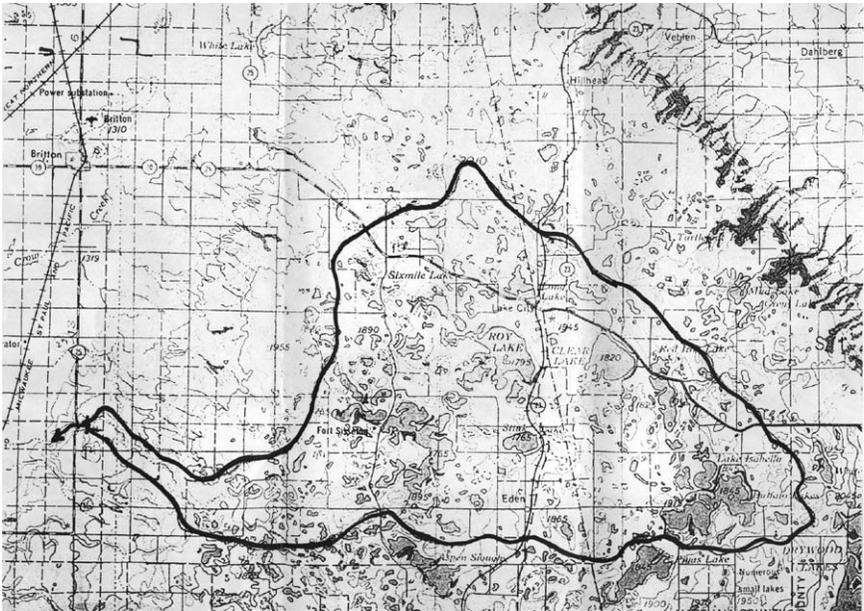
Figure 1. Topographic map of part of the USGS Milbank quadrangle, South Dakota, originally at 1:250,000 scale. The drainage basin of Crow Creek above Hickman Dam is outlined, representing an area of 170 sq. miles.

As the last of the glaciers melted approximately 20,000 years ago, blocks of ice left within the moraines melted, leaving depressions known as kettles. Small kettles are locally called potholes. Today many swamps and lakes in this area fill the depressions, occupying a single kettle or coalescing kettles. Figure 1 shows that the drainage basin that includes Fort Sisseton has a high density of kettles. Some of the larger lakes, such as Roy Lake, are not simply one large kettle, but were formed by constructional morainal development as well.

Inspection of topographic maps (Figure 1) indicates at first glance that most of the Glacial Lakes area has internal drainage. The land immediately adjacent to a typical kettle slopes into it and there is seemingly no outlet. But in extremely wet years, the kettles can fill up with water, and then overflow to adjacent kettles and lowlands. Some of the kettles probably have never filled up since they were formed some 20,000 years ago. In 1995 an unusually wet spring led to the filling of numerous kettles in this region, and the lakes began to coalesce into a giant complex and they finally spilled over to Crow Creek and thence into the James River and into the Missouri River.

The annual precipitation in Britton was 5.55 inches above normal in 1994, 7.45 inches above normal in 1995, 0.89 inches above normal in 1996, and 0.87 inches above normal in 1997 (NOAA, 1996-97). During the early summer of 1995, heavy rains filled the many depressions to the point where they began to overflow. [A tremendous volume of water is necessary to accomplish this, because the elevation of the bottom of the Cattail Lake kettle complex is approximately 1782 ft, based on the USGS 7.5 minute topographic maps, and the elevation of the water surface at its maximum depth over the Cattail Lake complex was about 1794 ft.] The order of filling in this region was from northeast to southwest, so that Buffalo Lake overflowed into Red Iron Lakes, and thence to Clear Lake, Roy Lake, Lost Lake, Kettle Lake, and finally Cattail Lake. Ultimately the water reached an outlet along the western shore of Cattail Lake, and on July 19, 1995, began flowing westerly off the Prairie Coteau. This outlet, formerly an unnamed slough, is now referred to as Cattail Creek. From July 19, 1995 until present (January, 1998), water has discharged continuously out of the Cattail Lake complex, except for the period January through March, 1997, when Cattail Creek froze up (Dan Hook, pers. comm., January 2, 1998). Cattail creek gradually increases in gradient westerly as it descends off the Prairie Coteau, ultimately descending into Crow Creek at Hickman Dam (Figure 1).

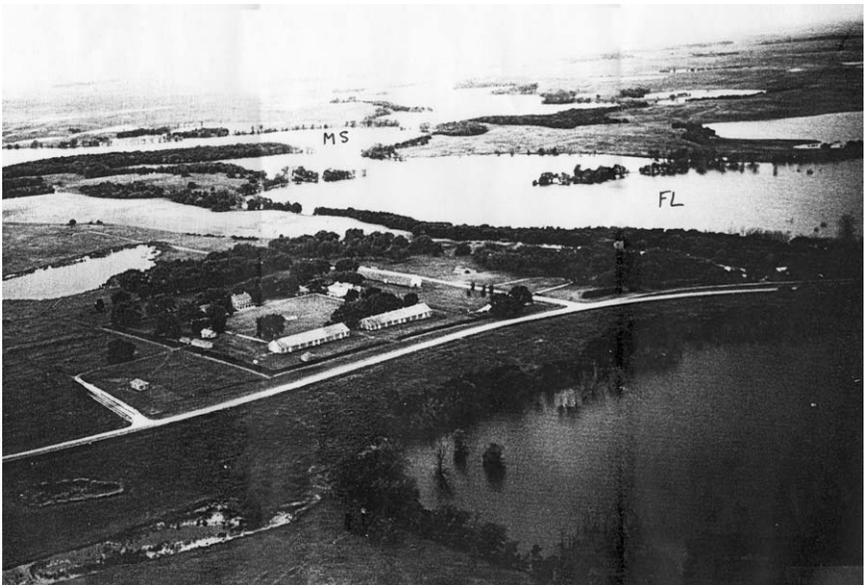
Figure 2. Oblique aerial photograph of Fort Sisseton, looking northwesterly. “Fort Lake” (FL) and “Mallard Slough” (MS) are full of water at the time of this photograph, July 17, 1996.

Figure 2 shows the high waters surrounding Fort Sisseton State Park. Mallard Slough is shown as a perennial lake on the USGS 1:24,000 scale topographic map, but Fort Lake is shown simply as a lowland swamp. In this 1996 photo, both depressions are completely full of water, and flow into and are merged with the Kettle Lake/Cattail Lake complex. Figure 3 shows the same depressions during the normally drier conditions which existed in 1975. Note the absence of Fort Lake.

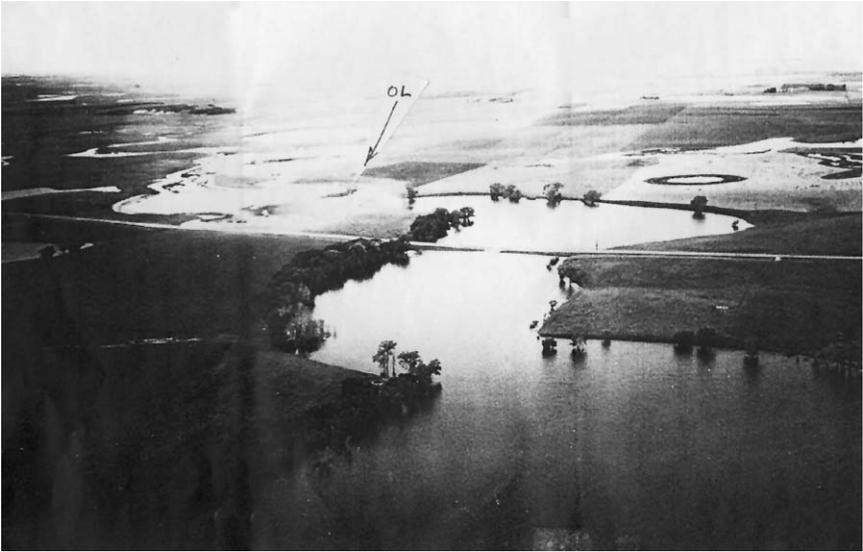
Figure 4. Oblique aerial photograph of Cattail Lake, looking westerly. This photograph was taken on July 16, 1996, and shows the lake has nearly submerged County Road #5. The outlet (Cattail Creek) is shown as "OL".

Figure 4 shows the County Road #5 crossing of Cattail Lake. This location is close to the outlet of the Cattail Lake complex as it existed in 1996. There is a culvert under the road at this location, and the operation of it was a factor in a

litigation brought about by landowners who claimed their lands were being inundated to some degree by roads constructed by the County Highway Department (Steiner et al. vs. Marshall County, South Dakota Supreme Court, 1997). The areas covered by water in Figure 4 are shown as hayfields in 1975 photos (Figure 3).

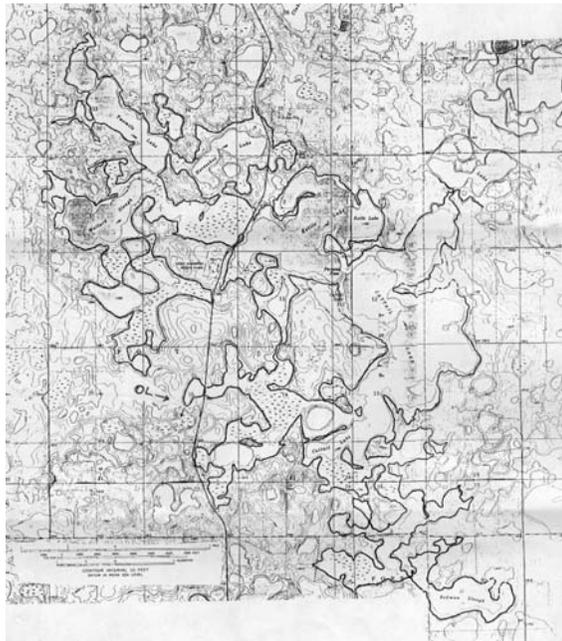
Figure 5. Portion of several USGS topographic maps, originally 1:24,000 scale. The Cattail Lake complex is shown, based on a 1794 ft. elevation from published contour lines. "OL" is the outlet from Cattail Lake.

Figure 5 is a detailed topographic map of the Cattail Lake and surrounding areas. The ground elevation of the outlet of Cattail Lake is 1792 ft above sea level. Outlined is the shoreline of the Cattail Lake complex based on the water surface elevation of 1794 ft. Waters remained at approximately this level from 1995 through 1998. Local residents do not recall the Cattail Lake complex filling ever before, although it reportedly did occur in 1916, the year the U.S. Soil Conservation Service (Schultz, 1975) reported as the wettest year in 54 years of record.

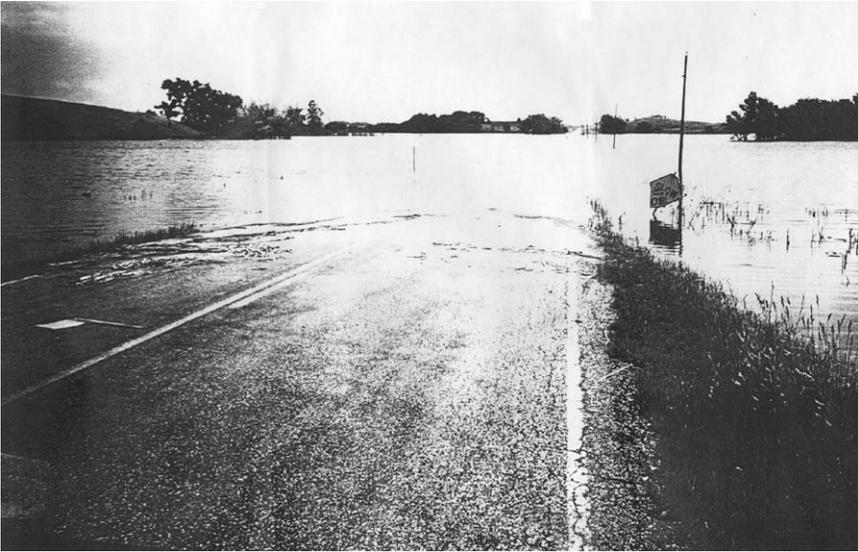
Figure 6. County Road #16, approximately 3 miles west of Lake Eden. This July 17, 1996 photograph shows the road submerged by an arm of Cattail Lake.

Flood damage to eastern South Dakota during the wet years of 1995 to 1998 was severe. Damage during 1996 alone reached an estimated \$46 million during the paralyzing blizzards and spring floods (Figure 6). Watertown was one of the
